**Flood Control Project Maintenance  
Levee Inspections**  
**LMA District Cover Sheet**  
**Spring 2017 Levee Inspection Results**

**Reclamation District No. 0017 Mossdale**

**Levee Inspection Report By Mile - Spring 2017**

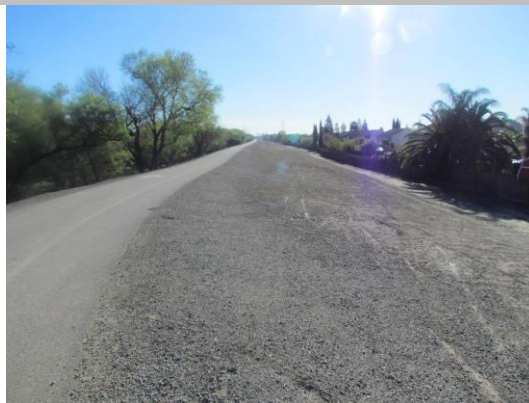
Photo 1 of 1 : SP\_2017\_RD0017\_303\_10\_20170330\_00016.jpg

LM Start	0.00	Rating **	A	Issue No.	10
LM End	1.76	Issue Type +	Ma	Location *	LS
Category	Earthen Levee			GPS Latitude/Longitude	
				Start	End
Item	Vegetation			37.911248 °	37.915968 °
				-121.291064 °	-121.320733 °
DWR ID	DWR_RD0017_01_s_2017_10				
Comment Code					
V1 : Control annual grass and weeds on the levee slopes and easements.					
Inspector Comment

Looking south at typical view of landward slope.

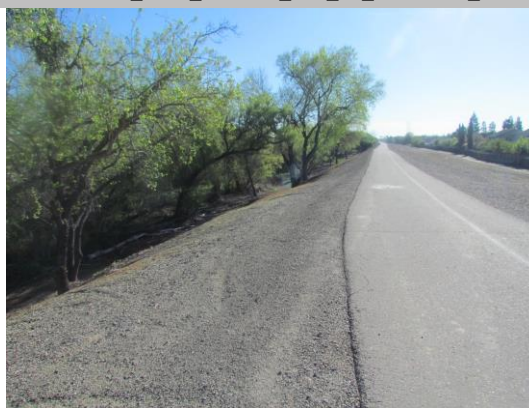
Photo 1 of 1 : SP\_2017\_RD0017\_303\_11\_20170330\_00017.jpg

LM Start	0.00	Rating **	A	Issue No.	11
LM End	1.76	Issue Type +	Ma	Location *	WS
Category	Earthen Levee			GPS Latitude/Longitude	
				Start	End
Item	Vegetation			37.911248 °	37.915968 °
				-121.291064 °	-121.320733 °
DWR ID	DWR_RD0017_01_s_2017_11				
Comment Code					
V1 : Control annual grass and weeds on the levee slopes and easements.					
Inspector Comment

Looking southeast at typical view of waterward slope.

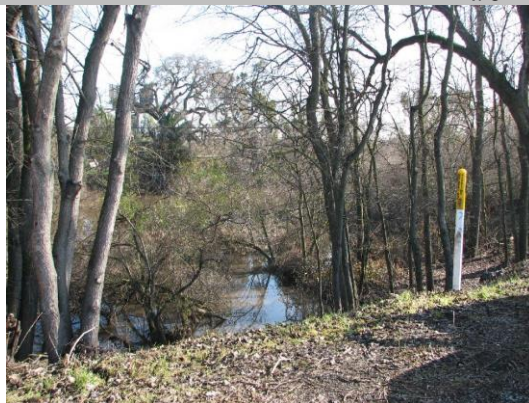
Photo 1 of 3 : UCIP\_SP\_2017\_40603\_38480.jpg

LM Start	0.03	Rating **	M	Issue No.	12
LM End	0.03	Issue Type +	En	Location *	WS
Category	Supplemental			GPS Latitude/Longitude	
				Start	End
Item	DWR UCIP Field Study			37.911561 °	37.911561 °
				-121.291441 °	-121.291441 °
DWR ID					
Comment Code					
Inspector Comment					
FS_ID:40603					
DS_ID:1					
EP_NO: 6623					
Repair Type: Non-Urgent					
Crossing Status: Found					
UCIP Comments: Marker missing on landward side. Need to contact owner to determine status of crossing. Need date of last inspection and confirmation that crossing is still in operable condition.					
FIELD_STRUCT_DESC: 5-inch diameter welded steel natural gas pipeline through the levees, 4.5 feet below the crown, across the channels and overflow area. (Permit No. 6623-1969)					
FS Date: 2/3/2010

View of waterward side.

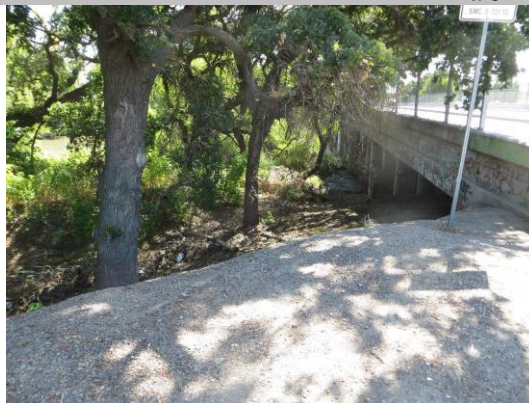
Photo 2 of 3 : UCIP\_SP\_2017\_49990\_74221.jpg

Comment Code					
Inspector Comment					
FS_ID:49990 DS_ID:72 EP_NO: 15185 Repair Type: Urgent Crossing Status: Indicator Found UCIP Comments: 7/12/2016 No markers (no photos taken in 2016). Need to contact owner to determine status of crossing. If crossing is active, owner will need to coordinate with CVFPB to install markers to comply with Title 23. (DWR UCIP - omagana)5/19/2015 Need to install gasoline markers. (DWR UCIP - omagana) FIELD_STRUCT_DESC: 8-inch soil proofed steel gas main through the left bank levee and under the channel of French Camp Slough. The pipeline has a minimum cover of 20 to 25 feet within the overflow areas and under the channel. (Permit No. 15185, 1989 - Pacific Gas & Electric Company [PG&E]) FS Date: 7/12/2016

WS Slope. No gasoline markers.

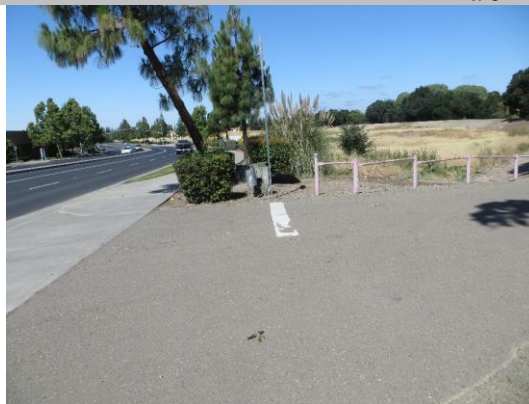
Photo 3 of 3 : UCIP\_SP\_2017\_49990\_74220.jpg

LS crown. No gasoline markers.

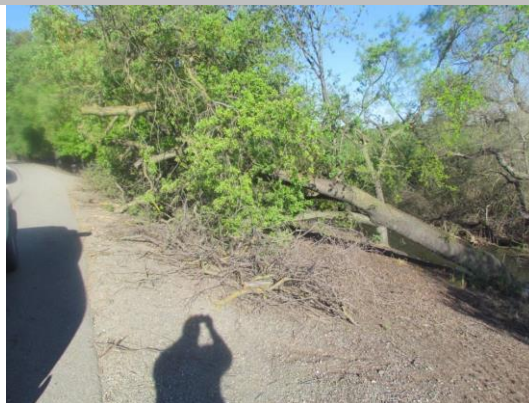
Photo 1 of 1 : SP\_2017\_RD0017\_303\_9\_20170330\_00018.jpg

LM Start	0.28	Rating **	M	Issue No.	9
LM End	0.28	Issue Type +	Ma	Location *	WS
Category	Earthen Levee			GPS Latitude/Longitude	
				Start	End
Item	Encroachments			37.913503 °	37.913503 °
				-121.294952 °	-121.294952 °
DWR ID	DWR_RD0017_01_s_2017_9				
Comment Code					
TR : Tree or limb					
Inspector Comment					
Fallen tree on waterward slope.

Looking northeast at fallen tree on waterward slope.

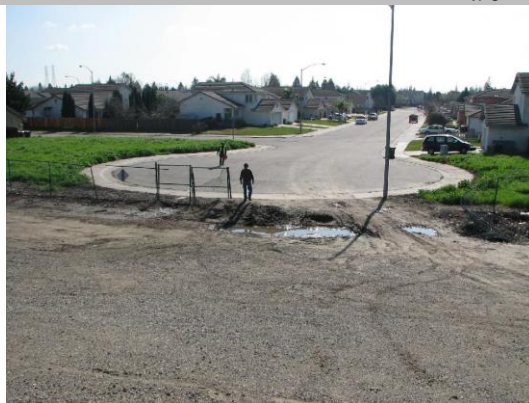
Photo 2 of 3 : UCIP\_SP\_2017\_40604\_38489.jpg

LM Start	1.31	Rating **	M	Issue No.	14 (cont)	
LM End	1.31	Issue Type +	En	Location *	WS	
Category	Supplemental			GPS Latitude/Longitude		
				Start	End	
Item	DWR UCIP Field Study			37.915928 °	37.915928 °	
				-121.312471 °	-121.312471 °	
DWR ID						
Comment Code						
Inspector Comment						
FS_ID:40604 DS_ID:2 EP_NO: 14992 Repair Type: Non-Urgent Crossing Status: Indicator Found UCIP Comments: Need to contact owner to determine status of crossing. Also need date of last inspection. FIELD_STRUCT_DESC: 1 of 3. 30-inch diameter HDPE sewer force main (SFM). All pipes encased in concrete at approximately 32 feet below levee crown. (Permit No. 14992-1989) FS Date: 2/3/2010

View of landward side.

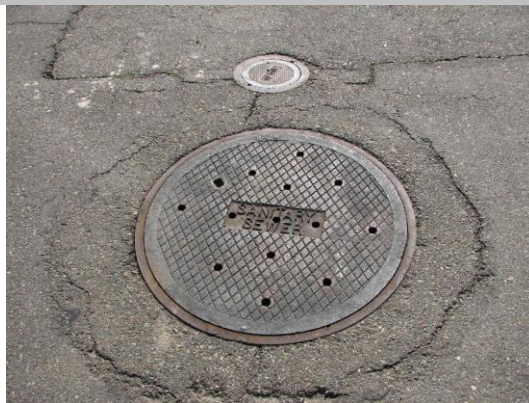
Photo 3 of 3 : UCIP\_SP\_2017\_40604\_38495.jpg

Manhole found on landward side.

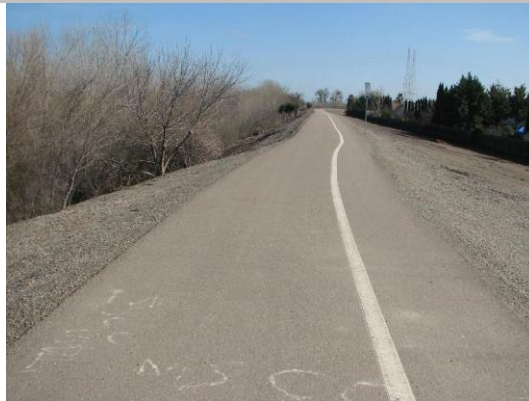
Photo 1 of 3 : UCIP\_SP\_2017\_40605\_38505.jpg

LM Start	1.31	Rating **	M	Issue No.	15
LM End	1.31	Issue Type +	En	Location *	WS
Category	Supplemental			GPS Latitude/Longitude	
				Start	End
Item	DWR UCIP Field Study			37.915928 °	37.915928 °
				-121.312471 °	-121.312471 °
DWR ID					
Comment Code					
Inspector Comment					
FS_ID:40605 DS_ID:159 EP_NO: 14992 Repair Type: Non-Urgent Crossing Status: Indicator Found UCIP Comments: Need to contact owner to determine status of crossing. Also need date of last inspection. FIELD_STRUCT_DESC: 2 of 3. A 30-inch diameter HDPE sewer force main (SFM). All pipes encased in concrete at approximately 32 feet below levee crown. (Permit No. 14992-1989) FS Date: 2/3/2010

Overview of levee at crossing.

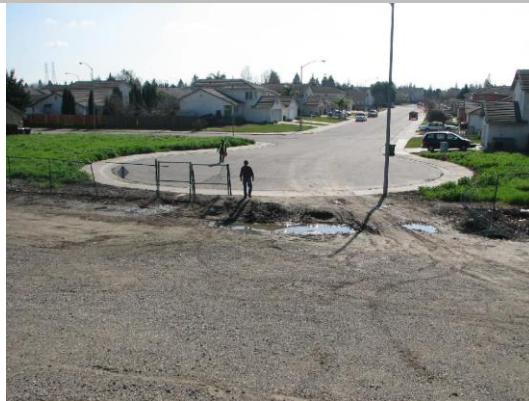
Photo 2 of 3 : UCIP\_SP\_2017\_40605\_38503.jpg

View of landward toe--established neighborhood.

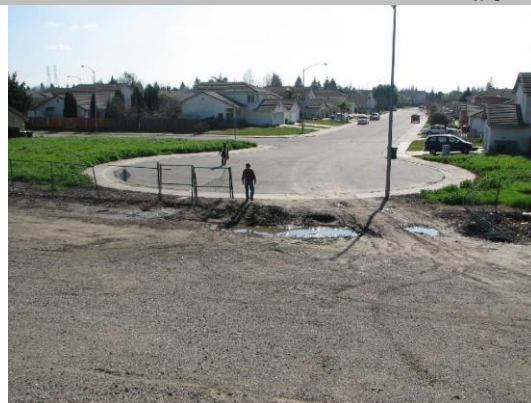
Photo 2 of 3 : UCIP\_SP\_2017\_40606\_71941.jpg

LM Start	1.31	Rating **	M	Issue No.	16 (cont)	
LM End	1.31	Issue Type +	En	Location *	WS	
Category	Supplemental			GPS Latitude/Longitude		
				Start	End	
Item	DWR UCIP Field Study			37.915928 °	37.915928 °	
				-121.312471 °	-121.312471 °	
DWR ID						
Comment Code						
Inspector Comment						
FS_ID:40606						
DS_ID:158						
EP_NO: 14992						
Repair Type: Non-Urgent						
Crossing Status: Indicator Found						
UCIP Comments: Need to contact owner to determine status of crossing. Also need date of last inspection.						
FIELD_STRUCT_DESC: 3 of 3. A 12-inch diameter HDPE sewer force main (SFM). All pipes encased in concrete at approximately 32 feet below levee crown. (Permit No. 14992-1989)						
FS Date: 2/3/2010

View of landward side.

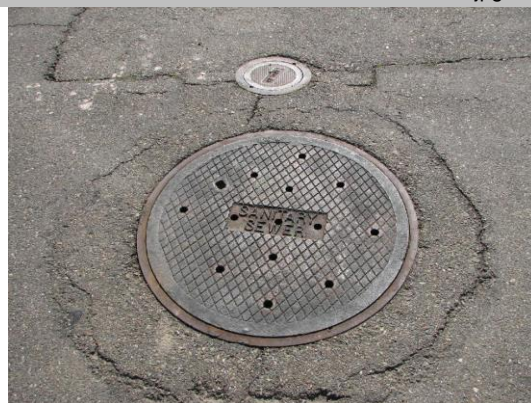
Photo 3 of 3 : UCIP\_SP\_2017\_40606\_71940.jpg

Manhole visible on landward side.

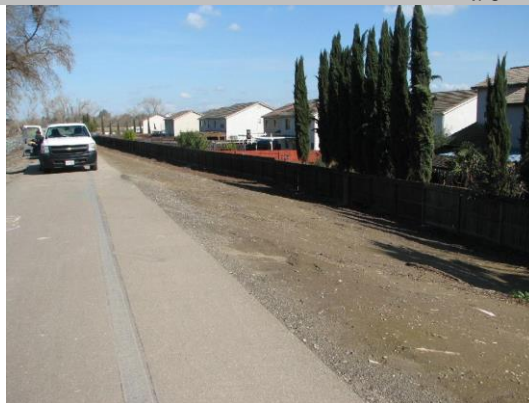
Photo 1 of 3 : UCIP\_SP\_2017\_40628\_38516.jpg

Comment Code					
Inspector Comment					
FS_ID:40628 DS_ID:75 EP_NO: 15093 Repair Type: Non-Urgent Crossing Status: Found UCIP Comments: Only appurtenances remaining at this location--4 pillings located on waterward side. According to records the pillings were to be removed under a completion maintenace contract. Need to coordinate with owner. FIELD_STRUCT_DESC: 14-inch-diameter pipeline through levee at unknown depth. Per inspector's notes "this crossing is abandoned almost all materials removed including pipes, conduit, and pumphouse. The only items left are 4 pilings which are to be removed under a completion maintenance contract. Approximately 200 feet of reinforced concrete pipe lateral removed in R/W south of crossing". FS Date: 2/3/2010

View of landward side.

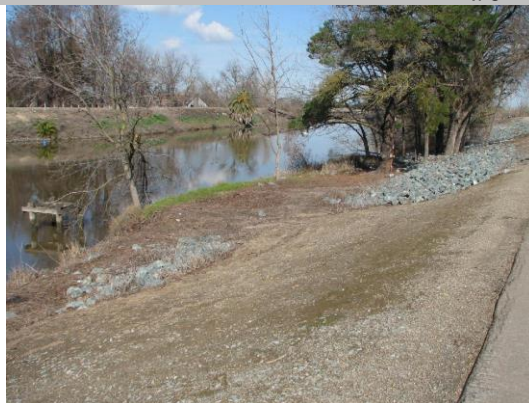
Photo 3 of 3 : UCIP\_SP\_2017\_40628\_38514.jpg

Comment Code						
Inspector Comment						
FS_ID:40628						
DS_ID:75						
EP_NO: 15093						
Repair Type: Non-Urgent						
Crossing Status: Found						
UCIP Comments: Only appurtenances remaining at this location--4 pillings located on waterward side. According to records the pillings were to be removed under a completion maintenace contract. Need to coordinate with owner.						
FIELD_STRUCT_DESC: 14-inch-diameter pipeline through levee at unknown depth. Per inspector's notes "this crossing is abandoned almost all materials removed including pipes, conduit, and pumphouse. The only items left are 4 pilings which are to be removed under a completion maintenance contract. Approximately 200 feet of reinforced concrete pipe lateral removed in R/W south of crossing".						
FS Date: 2/3/2010

View of waterward side.

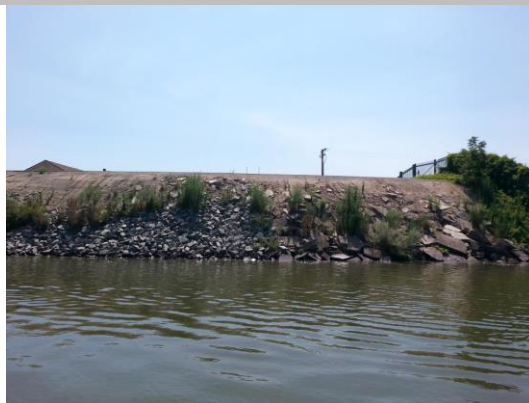
Photo 1 of 3 : SP\_2017\_RD0017\_304\_2\_20170316\_00003.jpg

LM Start	1.08	Rating **	U	Issue No.	2	
LM End	1.08	Issue Type +	Ma	Location *	WS	
Category	Supplemental			GPS Latitude/Longitude		
				Start		End
Item	DWR Erosion Survey			37.902530 °		37.902530 °
				-121.325690 °		-121.325690 °
DWR ID	DWR_RD0017_02_s_2017_2					
Comment Code						
Inspector Comment						
07/25/2016: No significant change observed. 06/24/2015: No significant change observed. 06/19/2014: No significant change observed. 08/13/2013: No significant change at this site. 08/07/2012: The erosion is nearly vertical, and has developed upward to halfway of the levee slope. The protecting concrete blocks have been washed away. Animal activities are visible. [2016 Site ID:RD0017U02RM44.32]. Repaired site

Front view of the erosion site. Note the concrete blocks and vegetation at the site.

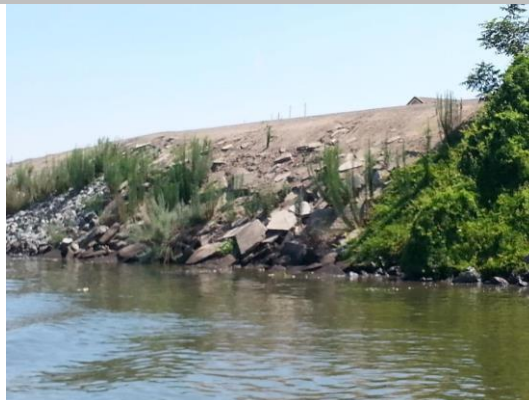
Photo 2 of 3 : SP\_2017\_RD0017\_304\_2\_20170316\_00004.jpg

Close view of the erosion.

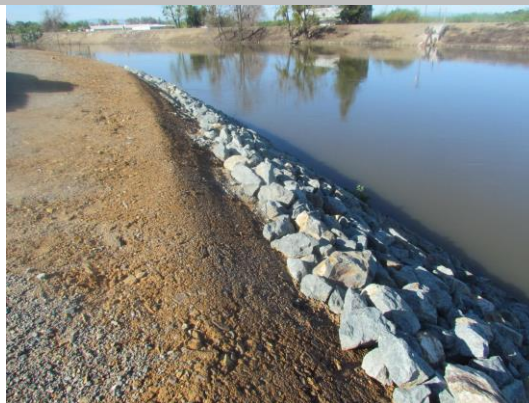
Photo 3 of 3 : SP\_2017\_RD0017\_304\_2\_20170330\_00191.jpg

LM Start	1.08	Rating **	U	Issue No.	2 (cont)	
LM End	1.08	Issue Type +	Ma	Location *	WS	
Category	Supplemental			GPS Latitude/Longitude		
				Start		End
Item	DWR Erosion Survey			37.902530 °		37.902530 °
				-121.325690 °		-121.325690 °
DWR ID	DWR_RD0017_02_s_2017_2					
Comment Code						
Inspector Comment						
07/25/2016: No significant change observed. 06/24/2015: No significant change observed. 06/19/2014: No significant change observed. 08/13/2013: No significant change at this site. 08/07/2012: The erosion is nearly vertical, and has developed upward to halfway of the levee slope. The protecting concrete blocks have been washed away. Animal activities are visible. [2016 Site ID:RD0017U02RM44.32]. Repaired site

Looking south at repaired site on waterward slope. (Spring 2017)

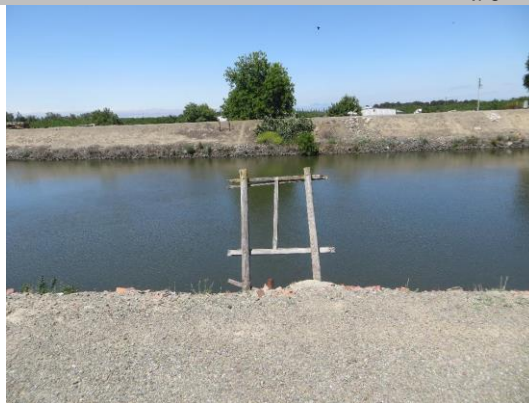
Photo 1 of 2 : UCIP\_SP\_2017\_45449\_74105.jpg

FS\_ID:45449  
DS\_ID:9  
EP\_NO: N/A  
Repair Type: Non-Urgent  
Crossing Status: Indicator Found  
UCIP Comments: Appears abandoned. Should contact owner to determine status as signs have been removed from supports and should be replaced if still in service.  
FIELD\_STRUCT\_DESC: Underground telephone cable through levee, 2 feet below crown. Warning signs on waterward slope.  
FS Date: 5/19/2015

Sign on WS slope.

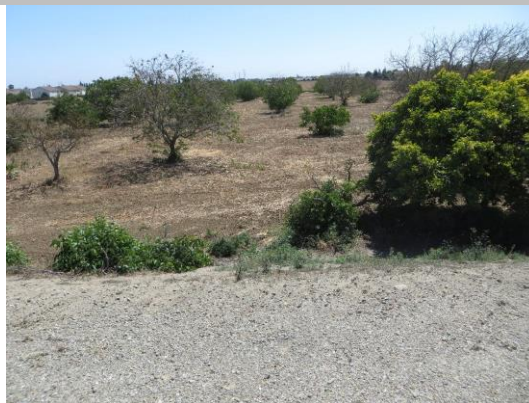
Photo 2 of 2 : UCIP\_SP\_2017\_45449\_74104.jpg

No markers on LS.

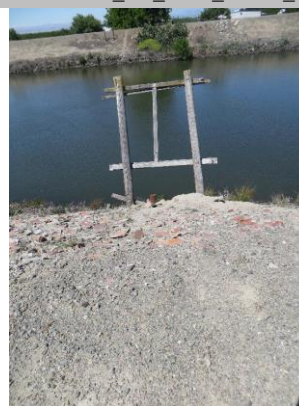
Photo 1 of 2 : UCIP\_SP\_2017\_45450\_74107.jpg

LM Start	1.18	Rating **	M	Issue No.	86
LM End	1.18	Issue Type +	En	Location *	LS
Category	Supplemental			GPS Latitude/Longitude	
				Start	End
Item	DWR UCIP Field Study			37.901012 °	37.901012 °
				-121.325497 °	-121.325497 °
DWR ID					
Comment Code					
Inspector Comment					
FS_ID:45450					
DS_ID:308					
EP_NO: N/A					
Repair Type: Non-Urgent					
Crossing Status: Indicator Found					
UCIP Comments: Appears Abandoned. Need to contact owner to determine status of crossing as signs have been removed from markers and should be replaced if still in service.					
FIELD_STRUCT_DESC: 4-inch submarine telephone cable through the levee, 2.0 feet below the crown, and across the channel. Location marker on the waterward slope.					
FS Date: 5/19/2015

Sign post on WS slope.

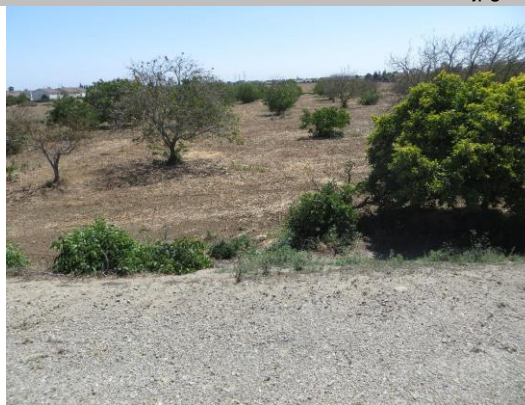
Photo 2 of 2 : UCIP\_SP\_2017\_45450\_74106.jpg

No markers on LS.

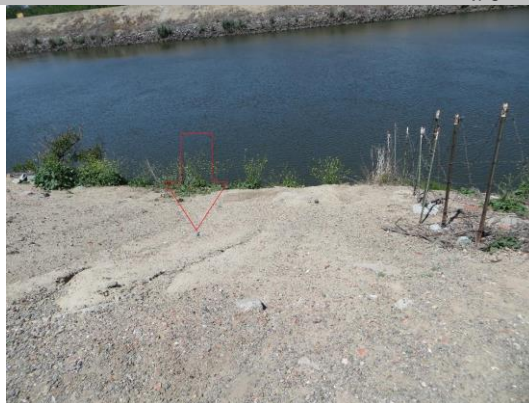
Photo 1 of 2 : UCIP\_SP\_2017\_49637\_74109.jpg

FS\_ID:49637  
DS\_ID:10  
EP\_NO: 15098  
Repair Type: Non-Urgent  
Crossing Status: Indicator Found  
UCIP Comments: 5/19/2015 Only signs of electrical conduit found. Need to contact owner to determine status of pipe as no record of removal has been found and only an electrical conduit was found at this location. (DWR UCIP - W. Wylie)  
FIELD\_STRUCT\_DESC: 8-inch steel irrigation pipe, 1 of 2 pipes, one (1) 8-inch pipe and one (1) 12-inch pipe, through the levee, 3.3 feet below levee crown. Electrical conduit through levee. Pump house located on waterward berm. Siphon breaker on waterward shoulder, standpipe located 10 feet from landward toe. (Permit No. 15098-1989).  
FS Date: 5/19/2015

View of WS slope with electrical conduit.

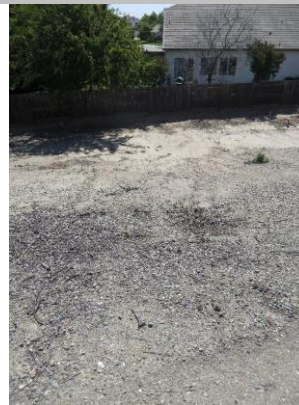
Photo 2 of 2 : UCIP\_SP\_2017\_49637\_74108.jpg

View of LS. No appurtances noted.

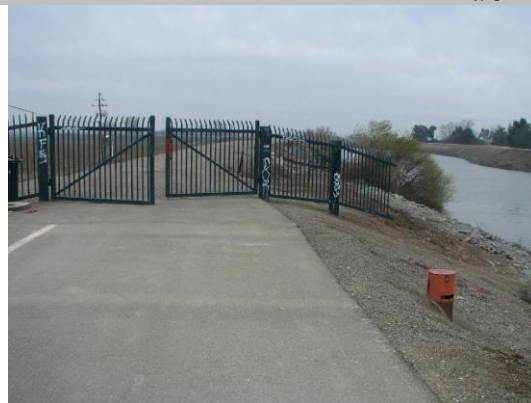
Photo 1 of 3 : UCIP\_SP\_2017\_40639\_38687.jpg

LM Start	1.45	Rating **	M	Issue No.	88
LM End	1.45	Issue Type +	En	Location *	LS
Category	Supplemental			GPS Latitude/Longitude	
				Start	End
Item	DWR UCIP Field Study			37.897280 °	37.897280 °
				-121.326775 °	-121.326775 °
DWR ID					
Comment Code					
Inspector Comment					
FS_ID:40639 DS_ID:11 EP_NO: 15316 Repair Type: Non-Urgent Crossing Status: Indicator Found UCIP Comments: Need to contact owner to determine status--pipe was not found only siphon breaker housing unit. FIELD_STRUCT_DESC: 8 inch diameter discharge pipeline through levee. Invert of pipe is 3.8 feet below levee crown. Siphon breaker on the waterward shoulder. Pump is located inside ditch located approximately 75 feet landward of levee toe. (Permit No. 15316-1989) FS Date: 2/4/2010

View of levee crown at crossing.

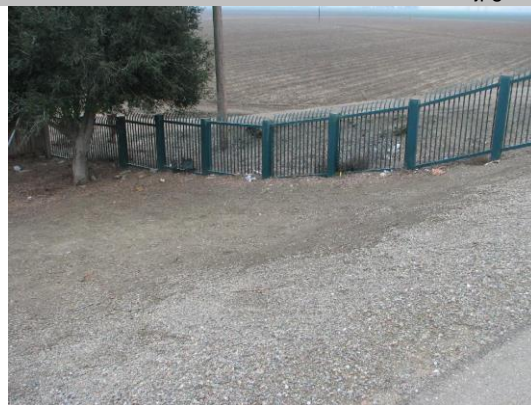
Photo 2 of 3 : UCIP\_SP\_2017\_40639\_38686.jpg

View of landward side.

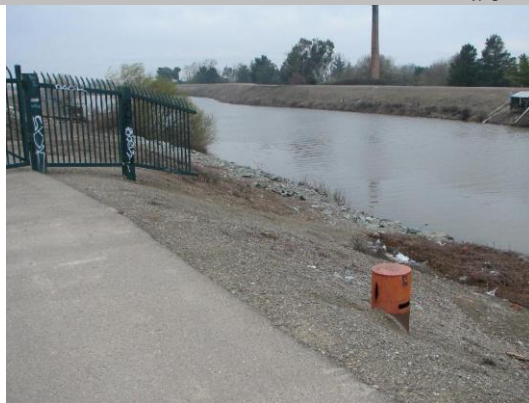
Photo 3 of 3 : UCIP\_SP\_2017\_40639\_38685.jpg

LM Start	<b>1.45</b>	Rating **	M	Issue No.	<b>88 (cont)</b>
LM End	<b>1.45</b>	Issue Type +	En	Location *	LS
Category	Supplemental		GPS Latitude/Longitude		
			Start	End	
Item	DWR UCIP Field Study		37.897280 °	37.897280 °	
			-121.326775 °	-121.326775 °	
DWR ID					
Comment Code					
Inspector Comment					
FS_ID:40639 DS_ID:11 EP_NO: 15316 Repair Type: Non-Urgent Crossing Status: Indicator Found UCIP Comments: Need to contact owner to determine status--pipe was not found only siphon breaker housing unit. FIELD_STRUCT_DESC: 8 inch diameter discharge pipeline through levee. Invert of pipe is 3.8 feet below levee crown. Siphon breaker on the waterward shoulder. Pump is located inside ditch located approximately 75 feet landward of levee toe. (Permit No. 15316-1989) FS Date: 2/4/2010

Siphon breaker located on waterward slope.

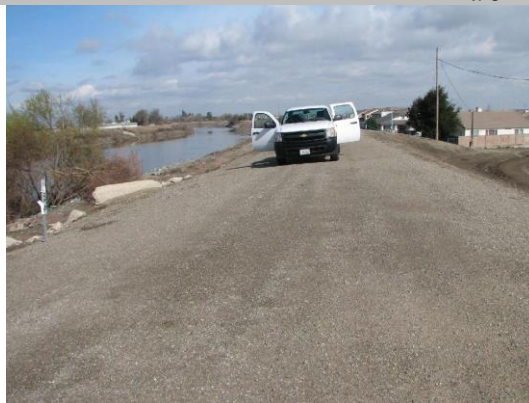
Photo 1 of 3 : UCIP\_SP\_2017\_40640\_71981.jpg

LM Start	<b>1.50</b>	Rating **	M	Issue No.	<b>89</b>
LM End	<b>1.50</b>	Issue Type +	En	Location *	LS
Category	Supplemental		GPS Latitude/Longitude		
			Start	End	
Item	DWR UCIP Field Study		37.896602 °	37.896602 °	
			-121.327104 °	-121.327104 °	
DWR ID					
Comment Code					
Inspector Comment					
FS_ID:40640 DS_ID:12 EP_NO: 15099 Repair Type: Non-Urgent Crossing Status: Found UCIP Comments: Need to coordinate with owner to determine status of crossing. If crossing is no longer in use owner will need to contact the CVFPB to comply with Title 23. FIELD_STRUCT_DESC: 16 inch diameter irrigation pipeline through levee. Invert of pipe is 3.64 feet below levee crown. Siphon breaker on waterward shoulder. Pump house located on the waterward berm. Standpipe located 15 feet from landward toe. Concrete stairway on waterward slope. (Permit No. 15099-1989) FS Date: 2/4/2010

View of levee crown at crossing.

Comment Code					
Inspector Comment					
FS_ID:40640					
DS_ID:12					
EP_NO: 15099					
Repair Type: Non-Urgent					
Crossing Status: Found					
UCIP Comments: Need to coordinate with owner to determine status of crossing. If crossing is no longer in use owner will need to contact the CVFPB to comply with Title 23.					
FIELD_STRUCT_DESC: 16 inch diameter irrigation pipeline through levee. Invert of pipe is 3.64 feet below levee crown. Siphon breaker on waterward shoulder. Pump house located on the waterward berm. Standpipe located 15 feet from landward toe. Concrete stairway on waterward slope. (Permit No. 15099-1989)					
FS Date: 2/4/2010

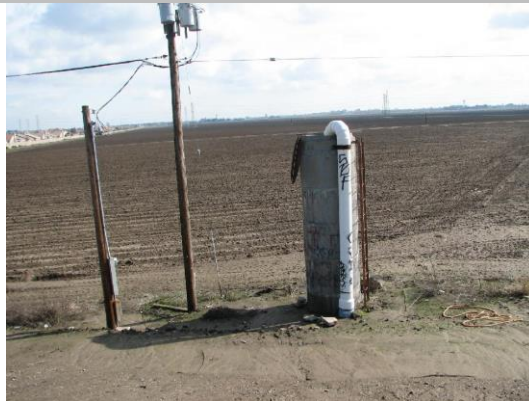
Photo 2 of 3 : UCIP\_SP\_2017\_40640\_38706.jpg

Standpipe located on landward side.

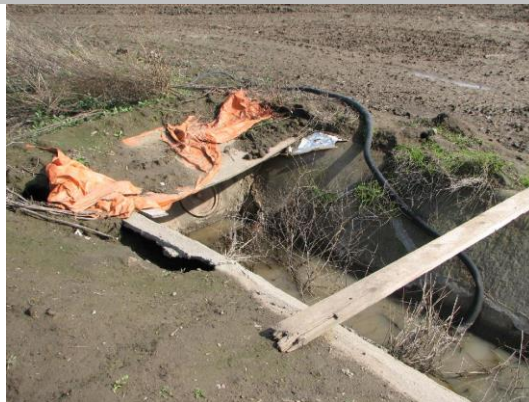
Photo 3 of 3 : UCIP\_SP\_2017\_40640\_71983.jpg

Concrete irrigation canal located at landward toe just upstream of crossing.

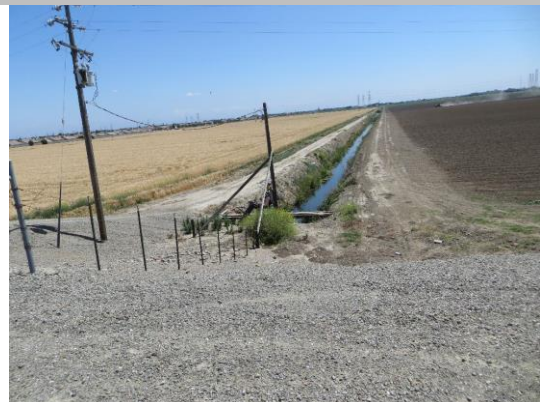
Photo 2 of 3 : UCIP\_SP\_2017\_49640\_74437.jpg

(2015) Damage pipe section located on WS toe has been replaced.

(2015) View of landward side.

FS\_ID:49640  
DS\_ID:13  
EP\_NO: 15100  
Repair Type: Non-Urgent  
Crossing Status: Found  
UCIP Comments: 09/07/2016 Need to coordinate with owner to determine if 12-inch pipe was sleeved through authorized 16-inch pipe. Unable to confirm if 12-inch pipe was authorized under Permit No. 15100. Also need to coordinate with owner to determine extent of repair to crossing--previous leak to WS pipe section. (DWR UCIP - O. Magana)05/19/2015 Notes were initially recorded under DS\_ID entry 82 due to field confirmed pipe size (12-inch and not 16-inch as described in permit). Record was updated to show 12 inch crossing was authorized under Permit 15100. UPDATED INFO @ CROSSING: Damage pipe section located on waterward toe has been replaced with new section. (DWR UCIP - O. Magana)02/0/2010 Holes in pipe at WS toe good indicator of pipe internal condition. Owner should perform an internal inspection of the pipe through the levee. (DWR UCIP - O. Magana)

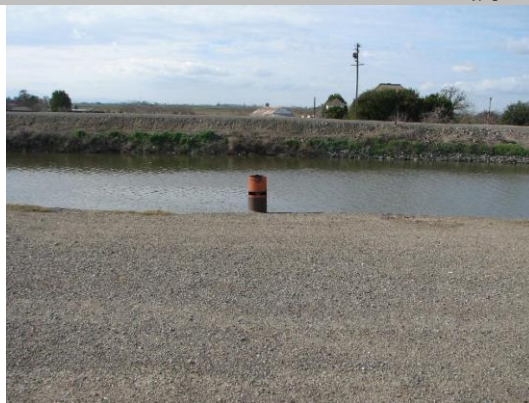
Photo 1 of 3 : UCIP\_SP\_2017\_40642\_38742.jpg

FS\_ID:40642  
DS\_ID:14  
EP\_NO: 15317  
Repair Type: Non-Urgent  
Crossing Status: Found  
UCIP Comments: Need to coordinate with owner to determine status of crossing. Need to find out if pipe located on landward side is tied to pipe through levee. Pipe found on waterward side is filled with concrete (non-functional).  
FIELD\_STRUCT\_DESC: 10 inch diameter steel stormwater discharge pipeline through levee. Invert of pipe is 4.74 feet below levee crown. Siphon breaker on waterward slope. Pump in ditch located 300 feet landward of toe. Ramp on landward slope. 10 inch pipe connects to an existing 16 inch discharge pipe on the landward side. (Permit No. 15317-1990) This pipe was installed during the levee work approved under encroachment number 15014.  
FS Date: 2/4/2010

View of waterward side--riser located on waterward shoulder.

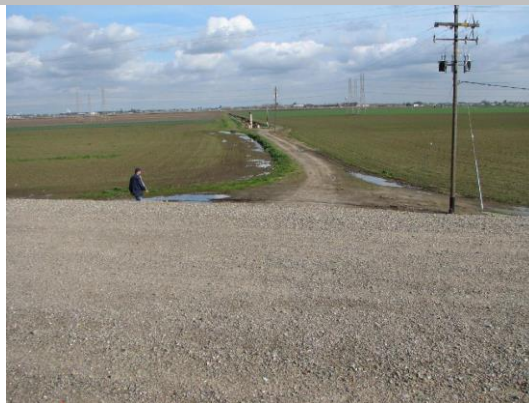
Photo 2 of 3 : UCIP\_SP\_2017\_40642\_38740.jpg

View of landward side.

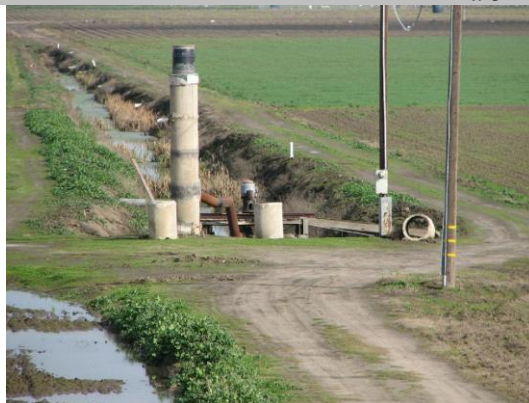
Photo 3 of 3 : UCIP\_SP\_2017\_40642\_38746.jpg

Comment Code						
Inspector Comment						
FS_ID:40642 DS_ID:14 EP_NO: 15317 Repair Type: Non-Urgent Crossing Status: Found UCIP Comments: Need to coordinate with owner to determine status of crossing. Need to find out if pipe located on landward side is tied to pipe through levee. Pipe found on waterward side is filled with concrete (non-functional). FIELD_STRUCT_DESC: 10 inch diameter steel stormwater discharge pipeline through levee. Invert of pipe is 4.74 feet below levee crown. Siphon breaker on waterward slope. Pump in ditch located 300 feet landward of toe. Ramp on landward slope. 10 inch pipe connects to an existing 16 inch discharge pipe on the landward side. (Permit No. 15317-1990) This pipe was installed during the levee work approved under encroachment number 15014. FS Date: 2/4/2010

Unidentified appurtenances located on landward side-unable to confirm if pipe crosses levee.

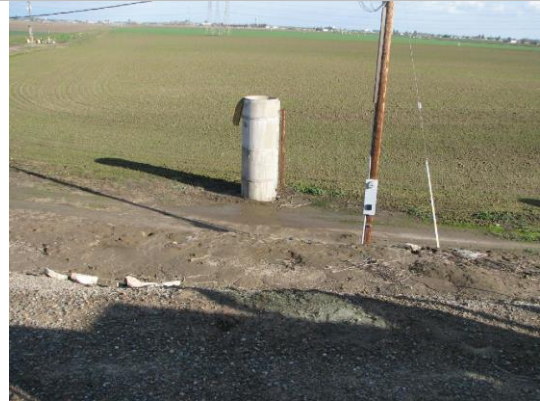
Photo 1 of 3 : UCIP\_SP\_2017\_49992\_38770.jpg

FS\_ID:49992  
 DS\_ID:15  
 EP\_NO: 15101  
 Repair Type: Non-Urgent  
 Crossing Status: Found  
 UCIP Comments: 7/12/2016 Rodent activity is present at this crossing. Unable to confirm if sink hole was present--depression near riser is still visible. Pipe was running during site visit. Crossing has been downgraded from Urgent to Non-Urgent---no damage was visible to levee crown or LS slope and only minor depression found around WS riser. Depression near siphon breaker on WS shoulder could be due to poor compaction or rodent activity--recommend monitoring site. Need to contact owner to determine if any internal integrity inspections have been done at this crossing. (DWR UCIP - omagana)2/04/2010 Sink hole present at siphon breaker riser located on waterward shoulder. Need to coordinate with owner to determine status of crossing. If crossing is no longer in use owner will need to contact the CVFPB to comply with Title 23. (DWR UCIP - omagana)

View of LS.

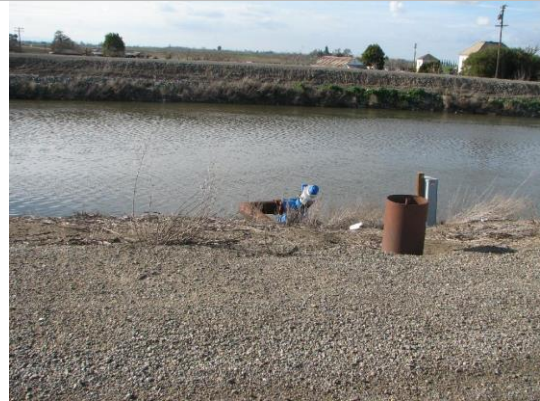
Photo 2 of 3 : UCIP\_SP\_2017\_49992\_38773.jpg

FS\_ID:49992  
 DS\_ID:15  
 EP\_NO: 15101  
 Repair Type: Non-Urgent  
 Crossing Status: Found  
 UCIP Comments: 7/12/2016 Rodent activity is present at this crossing. Unable to confirm if sink hole was present--depression near riser is still visible. Pipe was running during site visit. Crossing has been downgraded from Urgent to Non-Urgent---no damage was visible to levee crown or LS slope and only minor depression found around WS riser. Depression near siphon breaker on WS shoulder could be due to poor compaction or rodent activity--recommend monitoring site. Need to contact owner to determine if any internal integrity inspections have been done at this crossing. (DWR UCIP - omagana)2/04/2010 Sink hole present at siphon breaker riser located on waterward shoulder. Need to coordinate with owner to determine status of crossing. If crossing is no longer in use owner will need to contact the CVFPB to comply with Title 23. (DWR UCIP - omagana)

View of WS.

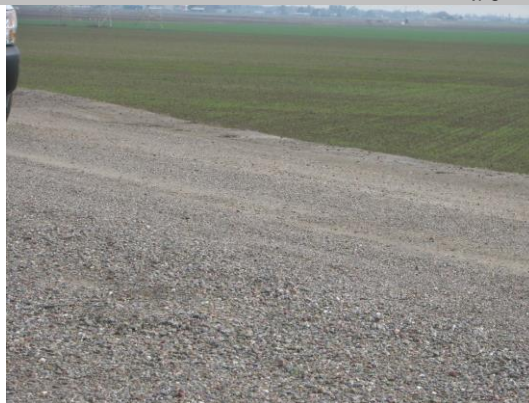
Photo 1 of 3 : UCIP\_SP\_2017\_40645\_72002.jpg

Comment Code					
Inspector Comment					
FS_ID:40645 DS_ID:16 EP_NO: 15102 Repair Type: Non-Urgent Crossing Status: Found UCIP Comments: Need to coordinate with owner to determine status of crossing. FIELD_STRUCT_DESC: 20 inch diameter irrigation pipeline through levee. Invert of pipe is 2.8 feet below levee crown. Fill placed over the pipeline to provide 2.0 feet of cover. Siphon breaker on waterward shoulder. Pump on platform with walkway to shoulder, standpipe located 15 feet landward tee, concrete stairway en waterward slope. (Permit No. 15102-1990) This pipe was installed during the levee work approved under encroachment number 15014. FS Date: 2/4/2010

View of levee crown at crossing.

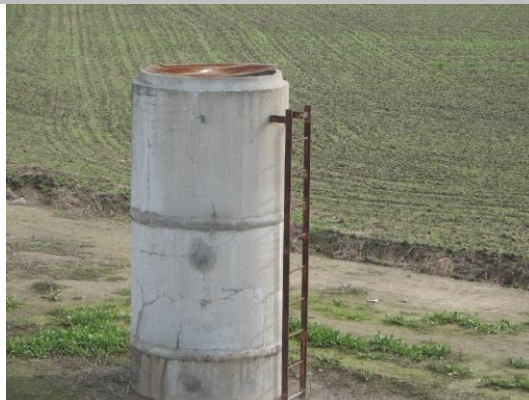
Photo 2 of 3 : UCIP\_SP\_2017\_40645\_72001.jpg

Standpipe located on landward toe.

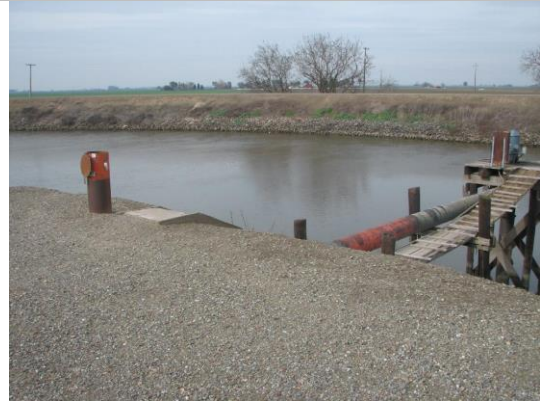
Photo 3 of 3 : UCIP\_SP\_2017\_40645\_72006.jpg

Comment Code						
Inspector Comment						
FS_ID:40645						
DS_ID:16						
EP_NO: 15102						
Repair Type: Non-Urgent						
Crossing Status: Found						
UCIP Comments: Need to coordinate with owner to determine status of crossing.						
FIELD_STRUCT_DESC: 20 inch diameter irrigation pipeline through levee. Invert of pipe is 2.8 feet below levee crown. Fill placed over the pipeline to provide 2.0 feet of cover. Siphon breaker on waterward shoulder. Pump on platform with walkway to shoulder, standpipe located 15 feet landward tee, concrete stairway en waterward slope. (Permit No. 15102-1990) This pipe was installed during the levee work approved under encroachment number 15014.						
FS Date: 2/4/2010

Overview of waterward side.

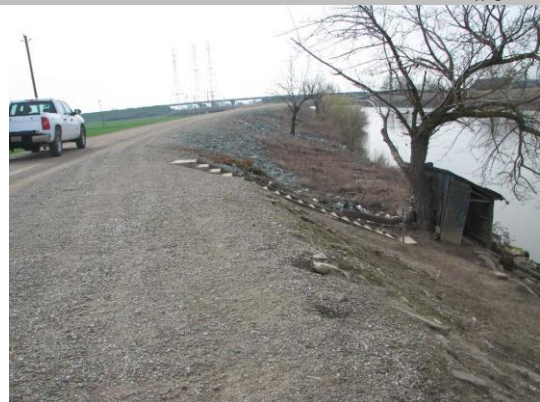
Photo 1 of 3 : UCIP\_SP\_2017\_40646\_72010.jpg

Comment Code					
Inspector Comment					
FS_ID:40646					
DS_ID:17					
EP_NO: 15103					
Repair Type: Non-Urgent					
Crossing Status: Found					
UCIP Comments: Need to coordinate with owner to determine status of crossing. If crossing is no longer in use owner will need to contact the CVFPB to comply with Title 23.					
FIELD_STRUCT_DESC: 8 inch diameter steel irrigation pipeline through levee. Invert of pipe is 3.47 feet below crown. Siphon breaker on landward shoulder. Pump house on waterward slope, standpipe located 10 feet from landward tee. Concrete stairway on waterward slope. (Permit No. 15103-1990) This pipe was installed during the levee work approved under encroachment number 15014.					
FS Date: 2/4/2010

View of waterward side.

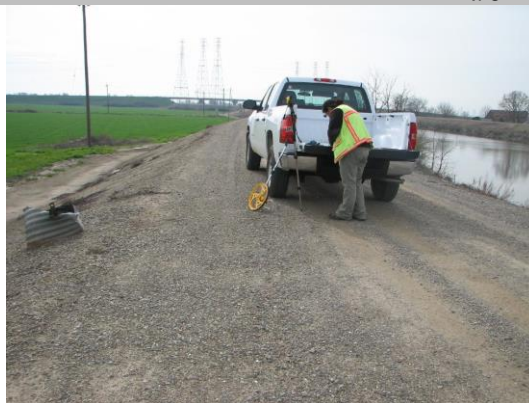
Photo 2 of 3 : UCIP\_SP\_2017\_40646\_72009.jpg

View of levee crown at crossing.

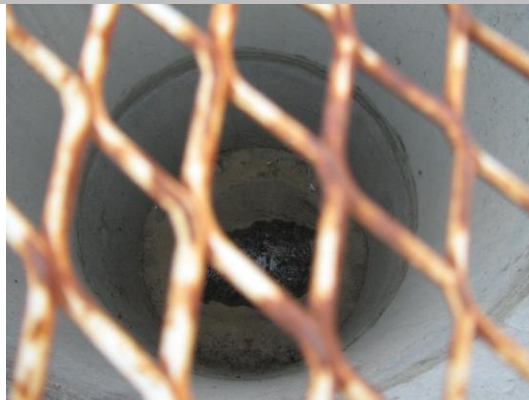
Photo 3 of 3 : UCIP\_SP\_2017\_40646\_72008.jpg

Inside view of standpipe located on landward side.

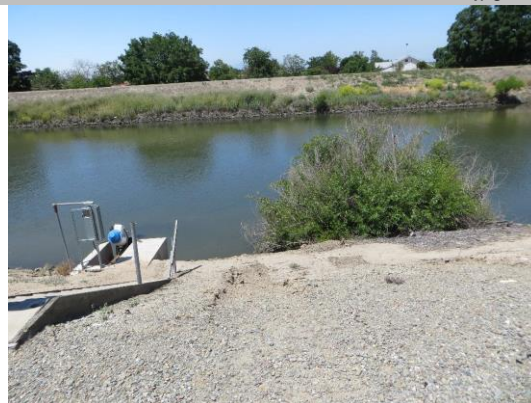
Photo 1 of 3 : UCIP\_SP\_2017\_46009\_74439.jpg

Comment Code					
Inspector Comment					
FS_ID:46009					
DS_ID:315					
EP_NO: N/A					
Repair Type: Non-Urgent					
Crossing Status: Found					
UCIP Comments: 05/19/15 Pipe has been removed. Need to contact KSN, engineering consultants for LMA, to obtain records showing pipe removal and obtain permit authoring work. 02/04/10 Hole present on waterward side pipe--historical records indicate crossing abandoned however unable to confirm. Unable to confirm condition of pipe through levee. Need to coordinate with owner to determine status of crossing. If crossing is no longer in use owner will need to contact the CVFPB to comply with Title 23.					
FIELD_STRUCT_DESC: *REMOVED* 4-inch pipe through the levee, 2.0 feet below the crown. Pump on concrete pad on the waterward slope. Gate valve on the waterward slope. Pipe open on both ends.					
FS Date: 5/19/2015

(2015) View of waterward slope.

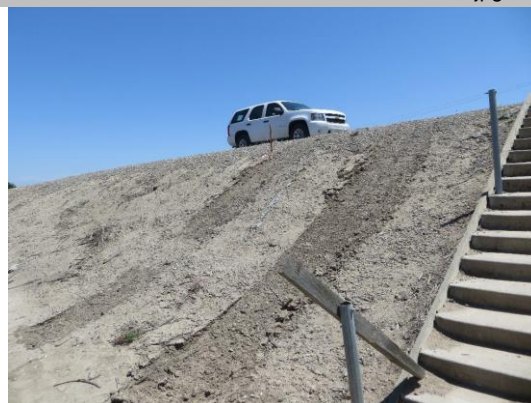
Photo 2 of 3 : UCIP\_SP\_2017\_46009\_74441.jpg

(2015) View of waterward slope--pipe removed.

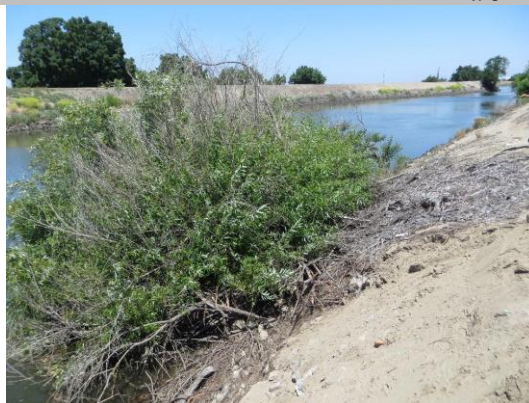
Photo 3 of 3 : UCIP\_SP\_2017\_46009\_74438.jpg

Comment Code						
Inspector Comment						
FS_ID:46009						
DS_ID:315						
EP_NO: N/A						
Repair Type: Non-Urgent						
Crossing Status: Found						
UCIP Comments: 05/19/15 Pipe has been removed. Need to contact KSN, engineering consultants for LMA, to obtain records showing pipe removal and obtain permit authoring work. 02/04/10 Hole present on waterward side pipe--historical records indicate crossing abandoned however unable to confirm. Unable to confirm condition of pipe through levee. Need to coordinate with owner to determine status of crossing. If crossing is no longer in use owner will need to contact the CVFPB to comply with Title 23.						
FIELD_STRUCT_DESC: *REMOVED* 4-inch pipe through the levee, 2.0 feet below the crown. Pump on concrete pad on the waterward slope. Gate valve on the waterward slope. Pipe open on both ends.						
FS Date: 5/19/2015

(2015) Pipe removed from waterward toe.

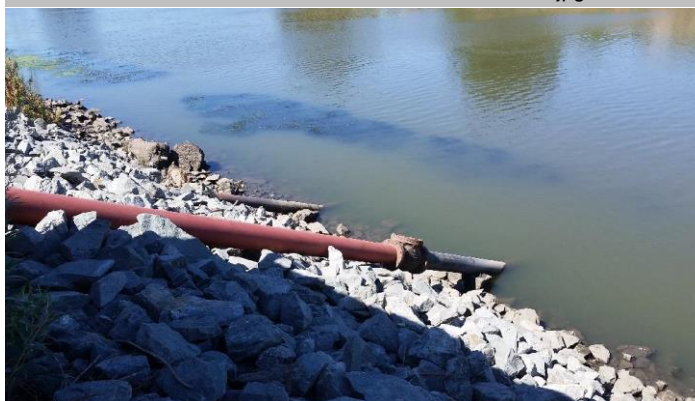
Photo 1 of 3 : UCIP\_SP\_2017\_49993\_75736.jpg

FS\_ID:49993  
DS\_ID:278  
EP\_NO: 15104  
Repair Type: Urgent  
Crossing Status: Found  
UCIP Comments: 7/12/2016 Same as previous inspection. Holes visible along exposed WS section of pipe. (DWR UCIP - omagana)5/19/2015 Holes through pipe visible on waterward toe. Recommend contacting owner to confirm pipe use--good candidate for internal inspection. (DWR UCIP - omagana)2/04/2010 Need to coordinate with owner to determine status of crossing. If crossing is no longer in use owner will need to contact the CVFPB to comply with Title 23. (DWR UCIP - omagana)  
FIELD\_STRUCT\_DESC: 3 of 3: 8-inch steel irrigation pipe through the levee, 2.85 feet below levee crown. Pump station is located on waterside (WS). Concrete standpipe is located on the landside (LS) toe. Pipe was installed as part of the re-shaping of RD17 project levees in 1989. The re-shaping of the levees was to increase levee elevations and provide freeboard above 100-year stages in both the San Joaquin River and French Camp Slough; work was authorized and documented under Permit No. 15014. (Permit No. 15104, 1989 - R. Romonda and C. Young; levee re-shaping authorized under Permit No. 15014, 1989 - Reclamation District 17). [Additional Reference(s): DWR Levee Log, 1981 and 2003]

View of WS, photo taken downstream looking at upstream pipe. Photo 1 of 2.

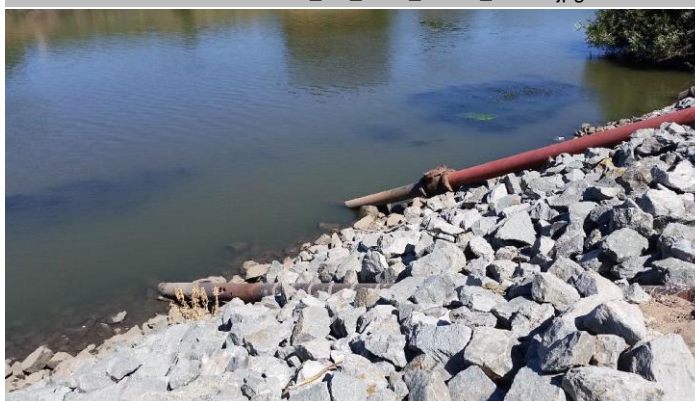
Photo 2 of 3 : UCIP\_SP\_2017\_49993\_75733.jpg

View of WS, photo taken upstream looking at first pipe. Photo 1 of 2.

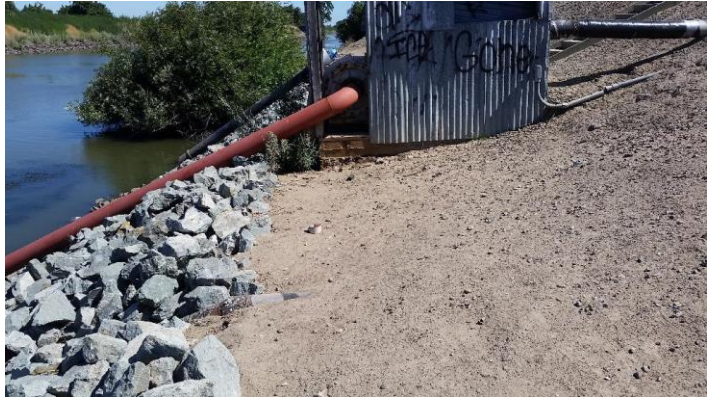
Photo 3 of 3 : UCIP\_SP\_2017\_49993\_75734.jpg

FS\_ID:49993  
DS\_ID:278  
EP\_NO: 15104  
Repair Type: Urgent  
Crossing Status: Found  
UCIP Comments: 7/12/2016 Same as previous inspection. Holes visible along exposed WS section of pipe. (DWR UCIP - omagana)5/19/2015 Holes through pipe visible on waterward toe. Recommend contacting owner to confirm pipe use--good candidate for internal inspection. (DWR UCIP - omagana)2/04/2010 Need to coordinate with owner to determine status of crossing. If crossing is no longer in use owner will need to contact the CVFPB to comply with Title 23. (DWR UCIP - omagana)  
FIELD\_STRUCT\_DESC: 3 of 3: 8-inch steel irrigation pipe through the levee, 2.85 feet below levee crown. Pump station is located on waterside (WS). Concrete standpipe is located on the landside (LS) toe. Pipe was installed as part of the re-shaping of RD17 project levees in 1989. The re-shaping of the levees was to increase levee elevations and provide freeboard above 100-year stages in both the San Joaquin River and French Camp Slough; work was authorized and documented under Permit No. 15014. (Permit No. 15104, 1989 - R. Romonda and C. Young; levee re-shaping authorized under Permit No. 15014, 1989 - Reclamation District 17). [Additional Reference(s): DWR Levee Log, 1981 and 2003]

WS-pipe daylight just above rip rap near red pipe.

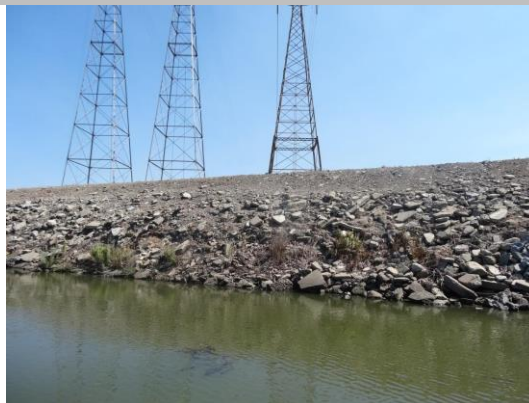
Photo 2 of 2 : SP\_2017\_RD0017\_304\_83\_20170316\_00010.jpg

LM Start	2.82	Rating **	M	Issue No.	83 (cont)
LM End	2.82	Issue Type +	Ma	Location *	WS
Category	Supplemental			GPS Latitude/Longitude	
				Start	End
Item	DWR Erosion Survey			37.878660 °	37.878660 °
				-121.332400 °	-121.332400 °
DWR ID	DWR_RD0017_02_s_2017_83				
Comment Code					
Inspector Comment					
07/25/2016: No significant change observed.					
06/24/2015: No significant change observed.					
06/19/2014: A pocket erosion was found during the boat survey. [2016 Site ID:RD0017U02RM46.1]

Close view of the erosion. The slope protection is poor.

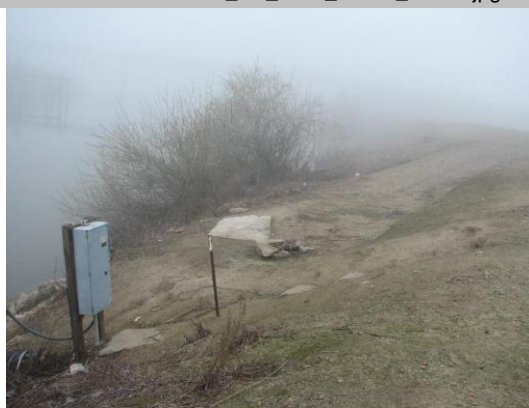
Photo 1 of 3 : UCIP\_SP\_2017\_40655\_72050.jpg

Comment Code					
Inspector Comment					
FS_ID:40655 DS_ID:20 EP_NO: 15106 Repair Type: Non-Urgent Crossing Status: Found UCIP Comments: Burrow activity dession on landward slope. Need to coordinate with owner to determine status of crossing. If crossing is no longer in use owner will need to contact the CVFPB to comply with Title 23. FIELD_STRUCT_DESC: 10 inch diameter irrigation pipeline through levee. Invert of pipe is 4.1 feet below levee crown. Siphon breaker on landward shoulder. Pump on waterward slope, standpipe located 14 feet landward of levee toe. (Permit No. 15106-1989) This pipe was installed during the levee work approved under encroachment number 15014. FS Date: 2/4/2010

View of waterward side.

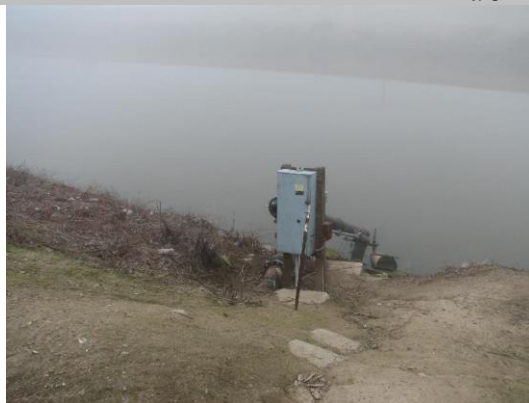
Photo 2 of 3 : UCIP\_SP\_2017\_40655\_72051.jpg

Comment Code						
Inspector Comment						
FS_ID:40655						
DS_ID:20						
EP_NO: 15106						
Repair Type: Non-Urgent						
Crossing Status: Found						
UCIP Comments: Burrow activity dession on landward slope. Need to coordinate with owner to determine status of crossing. If crossing is no longer in use owner will need to contact the CVFPB to comply with Title 23.						
FIELD_STRUCT_DESC: 10 inch diameter irrigation pipeline through levee. Invert of pipe is 4.1 feet below levee crown. Siphon breaker on landward shoulder. Pump on waterward slope, standpipe located 14 feet landward of levee toe. (Permit No. 15106-1989) This pipe was installed during the levee work approved under encroachment number 15014.						
FS Date: 2/4/2010

Pump station and control panel located on waterward side.

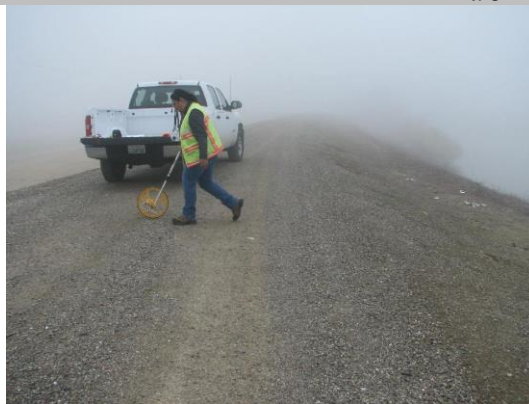
Photo 3 of 3 : UCIP\_SP\_2017\_40655\_72049.jpg

View of levee crown at crossing.

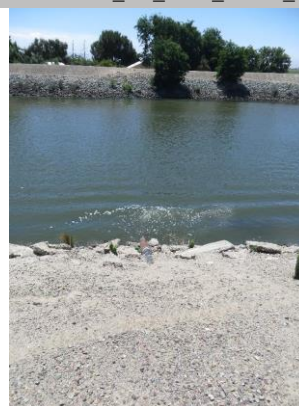
Photo 1 of 3 : UCIP\_SP\_2017\_46005\_74456.jpg

FS\_ID:46005  
DS\_ID:21  
EP\_NO: 15310  
Repair Type: Non-Urgent  
Crossing Status: Found  
UCIP Comments: 05/19/15 Deteriorated section of pipe has been replaced. Need to contact KSN, engineering consulting representing LMA, to determine repair details and to obtain permit authorizing repair. 02/04/10 Pipe wall deteriorated. Need to coordinate with owner to determine status of crossing. If crossing is no longer in use owner will need to contact the CVFPB to comply with Title 23.  
FIELD\_STRUCT\_DESC: 10 inch discharge pipeline through levee. The invert of the pipe is 3.78 feet below crown. Siphon breaker on landward shoulder. Pump located on the landward side approximately 45 feet from the levee toe. (Permit No. 15310-1989) This pipe was installed during the levee work approved under encroachment number 15014.  
FS Date: 5/19/2015

(2015) View of waterward side.

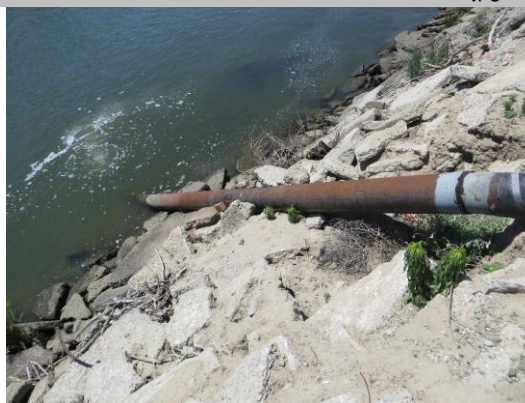
Photo 2 of 3 : UCIP\_SP\_2017\_46005\_74458.jpg

(2015) Pipe section replaced.

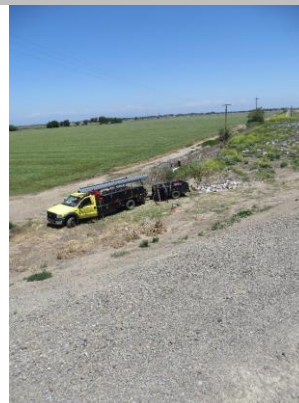
Photo 3 of 3 : UCIP\_SP\_2017\_46005\_74457.jpg

Comment Code						
Inspector Comment						
FS_ID:46005 DS_ID:21 EP_NO: 15310 Repair Type: Non-Urgent Crossing Status: Found UCIP Comments: 05/19/15 Deteriorated section of pipe has been replaced. Need to contact KSN, engineering consulting representing LMA, to determine repair details and to obtain permit authorizing repair.02/04/10 Pipe wall deteriorated. Need to coordinate with owner to determine status of crossing. If crossing is no longer in use owner will need to contact the CVFPB to comply with Title 23. FIELD_STRUCT_DESC: 10 inch discharge pipeline through levee. The invert of the pipe is 3.78 feet below crown. Siphon breaker on landward shoulder. Pump located on the landward side approximately 45 feet from the levee toe. (Permit No. 15310-1989) This pipe was installed during the levee work approved under encroachment number 15014. FS Date: 5/19/2015

(2015) View of landward side.

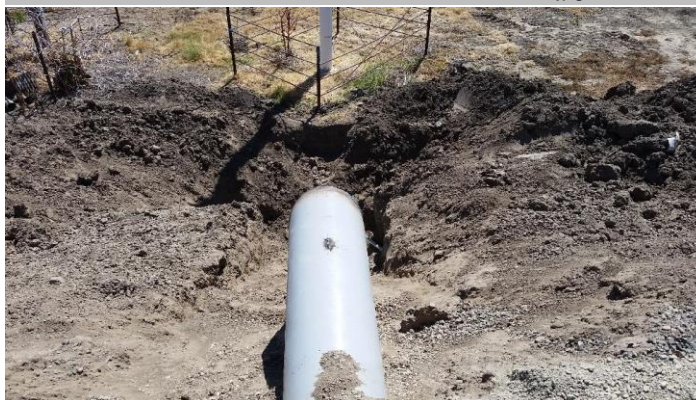
Photo 1 of 3 : UCIP\_SP\_2017\_50004\_75870.jpg

FS\_ID:50004  
DS\_ID:25466  
EP\_NO: N/A  
Repair Type: Non-Urgent  
Crossing Status: Found  
UCIP Comments: 7/12/2016 Under Construction--Missing permit information and as-built drawings. New pipe installed 7/12/2016, as an emergency repair--owner in the process of obtaining permit from CVFPB. This pipe replaces DS\_ID 22, pipe was removed July 2016. (DWR UCIP - omagana)  
FIELD\_STRUCT\_DESC: 16-inch steel irrigation pipe through the levee, X.XX feet below levee crown. Pump sits on the platform supported by steel piles located on the waterside (WS). Walkway extends from the pump platform to the WS. Positive closure device located on WS near walkway. (16-inch steel pipe installed under Permit No. XXXX, 2016 - XXXXX).  
FS Date: 7/12/2016

View of exposed pipe on LS--photo taken during install progress.

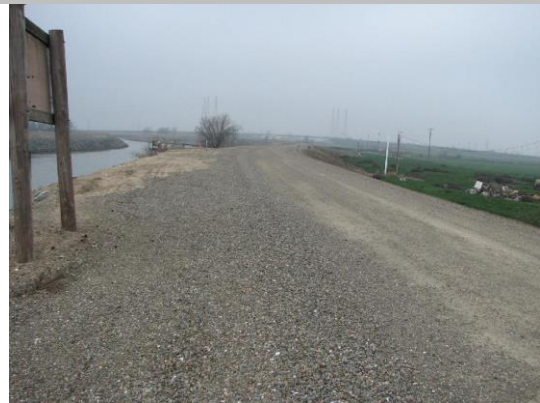
Photo 1 of 3 : UCIP\_SP\_2017\_40658\_72112.jpg

LM Start	3.47	Rating **	M	Issue No.	101
LM End	3.47	Issue Type +	En	Location *	WS
Category	Supplemental			GPS Latitude/Longitude	
				Start	End
Item	DWR UCIP Field Study			37.870623 °	37.870623 °
				-121.328775 °	-121.328775 °
DWR ID					
Comment Code					
Inspector Comment					
FS_ID:40658 DS_ID:23 EP_NO: 4116 Repair Type: Non-Urgent Crossing Status: Found UCIP Comments: Need to contact owner to determine status of crossing. Need date of last inspection and confirmation that crossing is still in operable condition. FIELD_STRUCT_DESC: 8 inch diameter high pressure gas main through the levee. Invert of pipe is 3.9 feet below the crown. Location sign for gas pipeline crossing on waterward slope. (Permit No. 4116-1962) PG&E contact information 510-779-4830 for crossing. FS Date: 2/4/2010

View of levee crown at crossing.

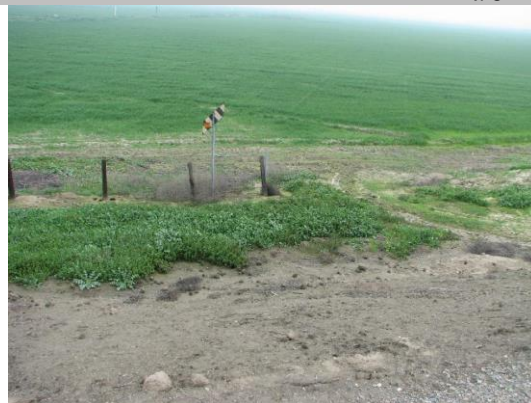
Photo 2 of 3 : UCIP\_SP\_2017\_40658\_72111.jpg

LM Start	3.47	Rating **	M	Issue No.	101 (cont)	
LM End	3.47	Issue Type +	En	Location *	WS	
Category	Supplemental			GPS Latitude/Longitude		
				Start	End	
Item	DWR UCIP Field Study			37.870623 °	37.870623 °	
				-121.328775 °	-121.328775 °	
DWR ID						
Comment Code						
Inspector Comment						
FS_ID:40658 DS_ID:23 EP_NO: 4116 Repair Type: Non-Urgent Crossing Status: Found UCIP Comments: Need to contact owner to determine status of crossing. Need date of last inspection and confirmation that crossing is still in operable condition. FIELD_STRUCT_DESC: 8 inch diameter high pressure gas main through the levee. Invert of pipe is 3.9 feet below the crown. Location sign for gas pipeline crossing on waterward slope. (Permit No. 4116-1962) PG&E contact information 510-779-4830 for crossing. FS Date: 2/4/2010

View of landward side.

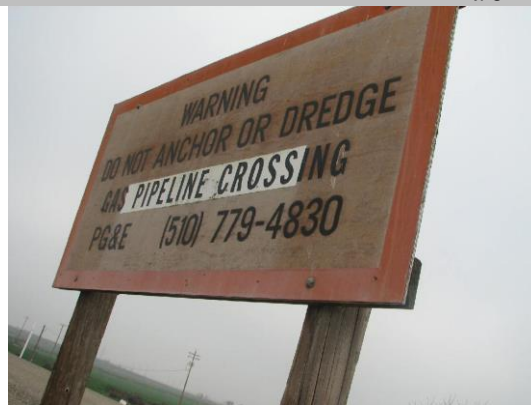
Photo 3 of 3 : UCIP\_SP\_2017\_40658\_72110.jpg

Marker visible on waterward side.
